RRS *Ernest Shackleton* – a breakthrough in icebreaker hull protection

Some background on the Royal Research Ship *Ernest Shackleton*

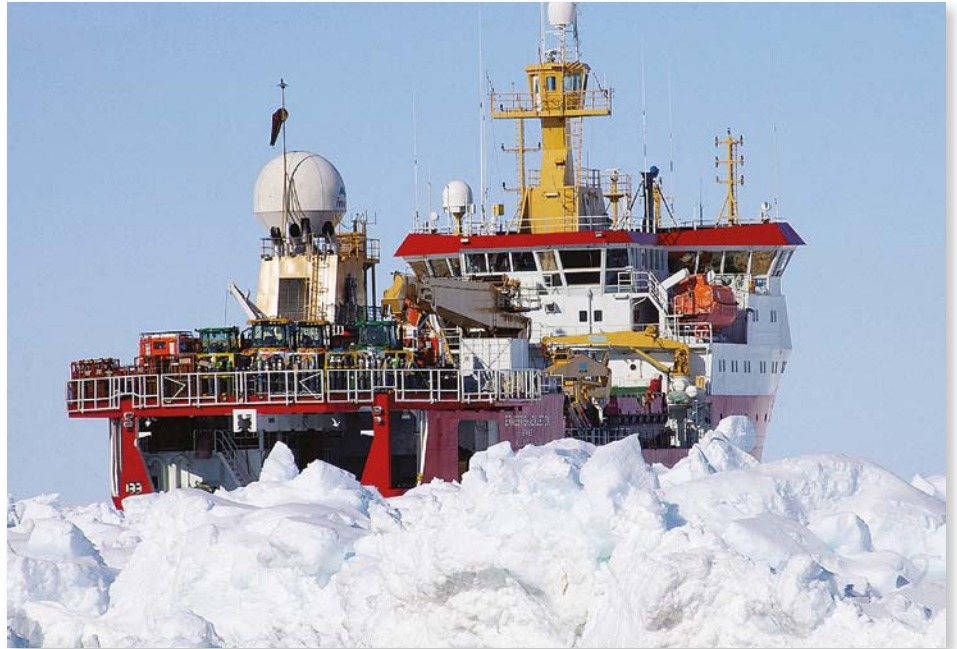
RRS Ernest Shackleton in Antarctic ice up to 2.5 m thick.

According to Stephen Lee, the crew of the *Shackleton* reported that they had been pushing into 2 - 2.5 meter thick ice, "...and it's just not touched it – just not touched it at all."

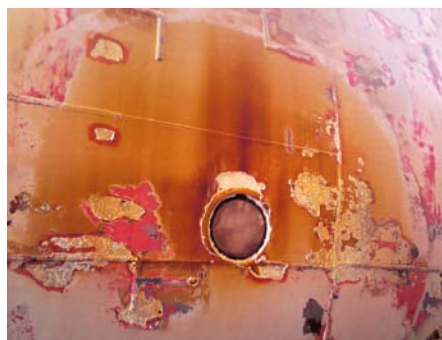
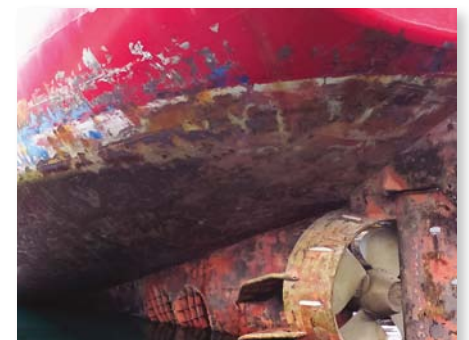
worth the proverbial thousand words. In this case, two sets of pictures tell the story more dramatically than any description. *Shackleton* was initially coated with a conventional ice class paint in 1995, from build. BAS took over the operation of the *Shackleton* in 1999 and since then has only ever

Three photos of the hull of RRS Ernest Shackleton showing the condition of the paint (conventional ice paint and corresponding repair coating) before Ecospeed was applied.

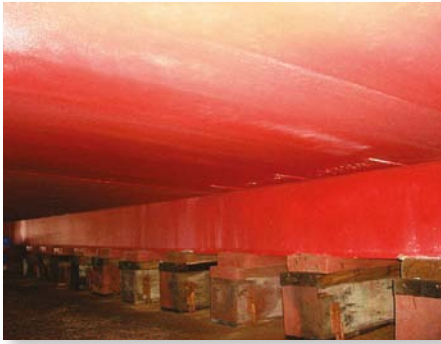
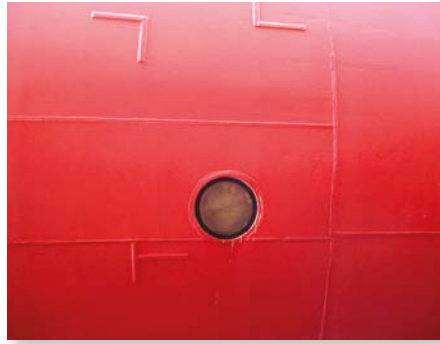
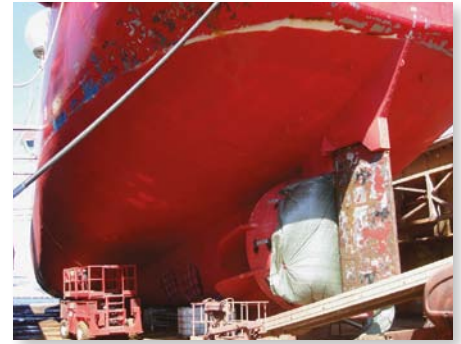
It is worth noting in the photos on the right above that neither the rudder nor the hull above the water line were coated with Ecospeed in 2009. This

Three comparison photos of similar areas of the hull after the switch to Ecospeed underwater hull coating system and two seasons of sailing in the ice. Note that the boot top and rudder, seen to have suffered damage in the photos on the right, were not coated with Ecospeed in 2009 along with the rest of the underwater hull. This has now been remedied in 2011.

has now been rectified in the 2011 drydocking so that the rudder and the hull above the water line will have the same protection as the rest of the ship bottom.

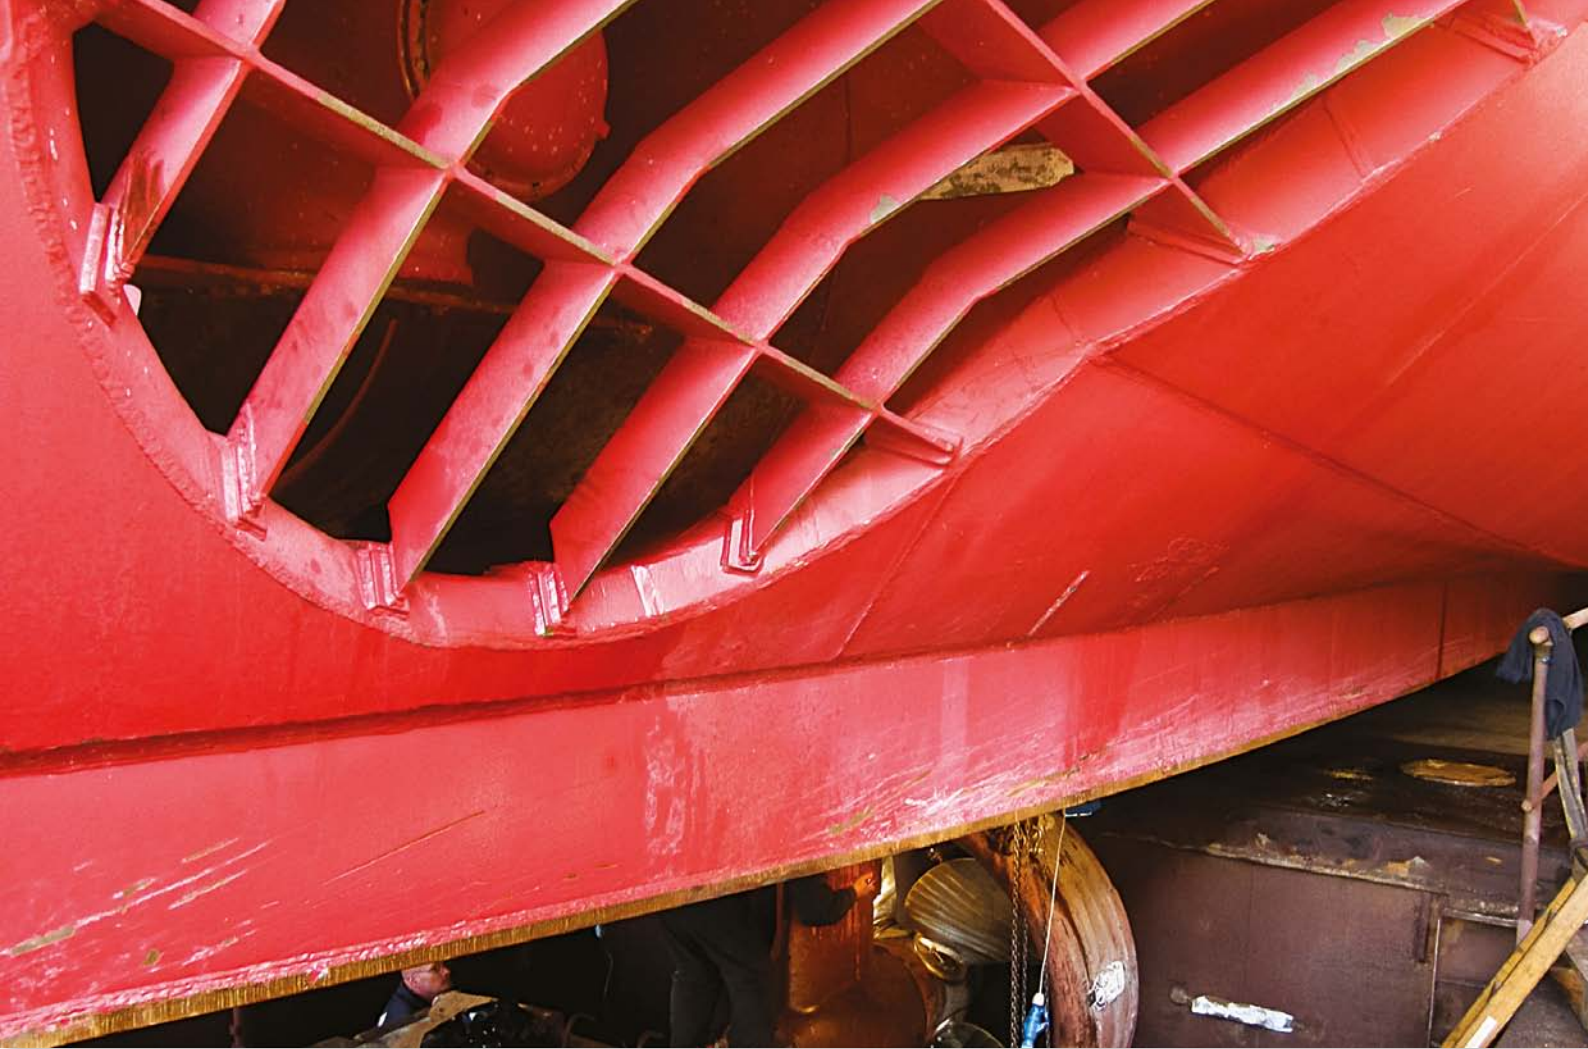
Examples of the minor scrapes and chips which were the totality of the damage to the Ecospeed coated hull after two seasons in the ice.

and found it was basically something around 970-1000 microns on average so it's hardly lost any thickness," Stephen explains. The original application of Ecospeed was 1000 microns DFT on the entire underwater hull.

Some minor mechanical damage had occurred to the coating but this amounted to some chips and scrapes totaling less than 0.1% of the total surface area. Compared to the virtual

total removal of all the paint which the crew of the *Shackleton* had become used to before the application of Ecospeed, the damage was negligible and easily repaired. Only very minor touch-ups were required in drydock.

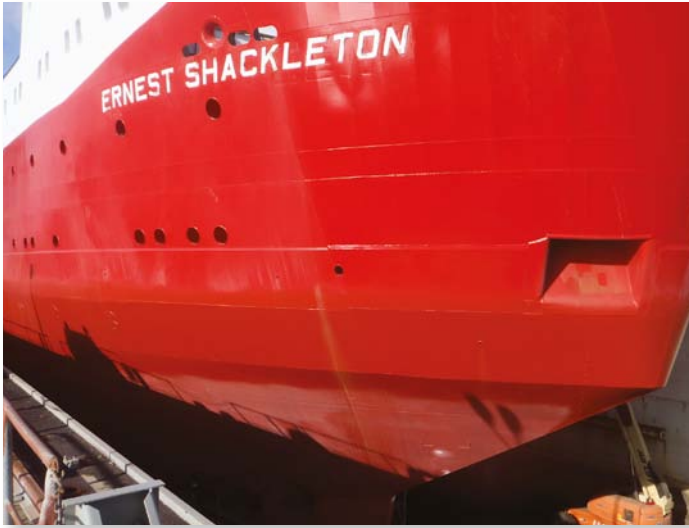
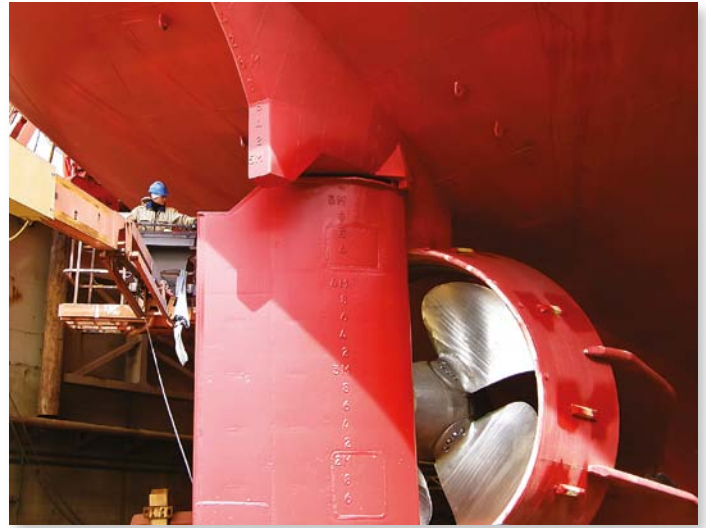
Newly Ecospeed coated boot top area above the water line

and rudder as the Ernest Shackleton is readied for departure from drydock.

ice belt where mechanical damage normally occurs. The rudder was also coated with Ecospeed during the 2011 drydocking so that it too could benefit from the same impenetrable protection as the hull.

Stephen Lee stated that BAS also took advantage of the fact that the ship was in drydock to apply Ecospeed to the rudder and the boot top area which had

not been included when the hull was coated in 2009.
