## Hydrex designs tailor made cofferdam for underwater replacement of boss head bolts of main propeller of ro/ro vessels

## On site seal repairs around the world keep ships out of drydock

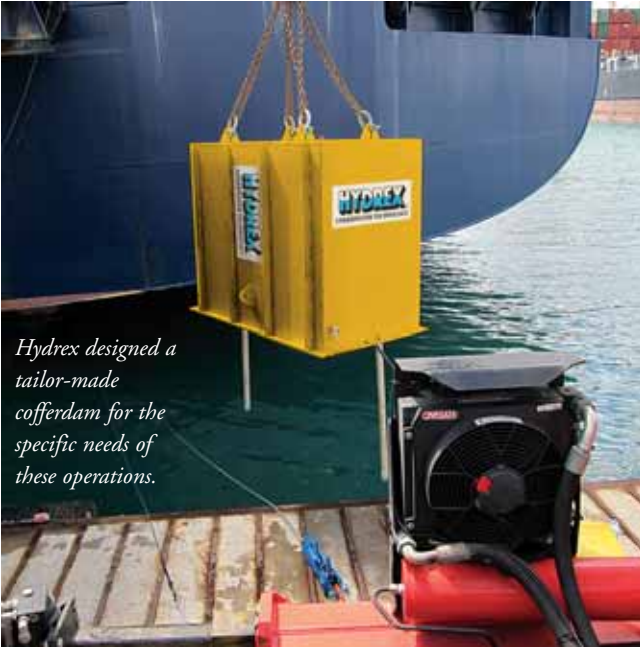
*Hydrex designed a tailor-made cofferdam for the specific needs of these operations.*

When several of the boss head bolts of the main propeller of a ro/ro vessel were found to be missing, the manufacturer asked Hydrex, headquartered in the Belgium port of Antwerp, to engineer a solution that would allow the replacement of these bolts on the vessel and similar vessels without having to go to drydock.

In close communication with the manufacturer, the Hydrex engineering department designed a special cofferdam that would fit the specific needs of these operations. This was complemented with a special procedure set up by the Hydrex technical department that would make sure that all safety and quality demands could be met during the replacement.

After the proposed cofferdam had been approved and constructed, the boss head bolts on the first of the ro/ro vessels were successfully replaced underwater by a Hydrex diver/technician team during the ship's stop at Port of Koper, Slovenia.

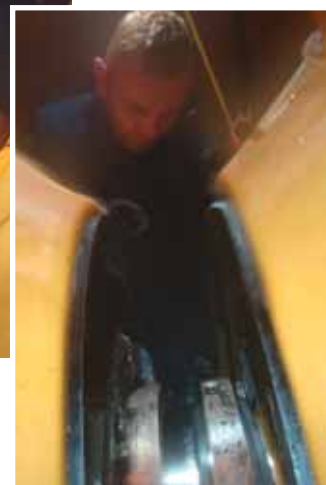
*Right: The Hydrex flexible mobdock allows The company to create a dry underwater environment.*

A team immediately left from the Hydrex office in Clearwater, Florida, together with the needed equipment, and set up a diving station at the berthing location of the ship. After the Hydrex flexible mobdock was installed around the stern tube seal assembly and a dry underwater environment was created, the damaged seals could be replaced.

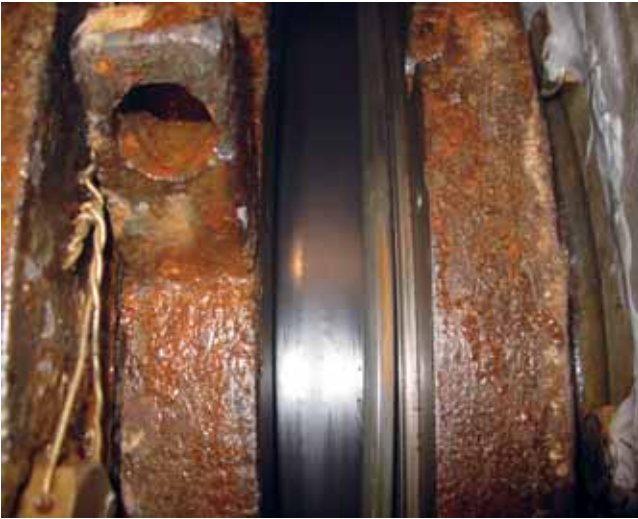
*Damaged stern tube seal.*

Still under terrible sea conditions, the rope guard was removed and an inspection revealed that a fishing net had been caught in the assembly and was tangled around the entirety of the seals. The flexible mobdock was then installed. This created a dry working environment for the divers at a depth of twelve meters in which they could replace the damaged seals.

Even though they were forced to halt the repair briefly during the peak of the typhoon, the team worked through the rest of the storm to make sure that the delay for the customer was kept to an absolute minimum. Very strict safety measures were taken during the entire operation, as is the case with every job Hydrex performs.

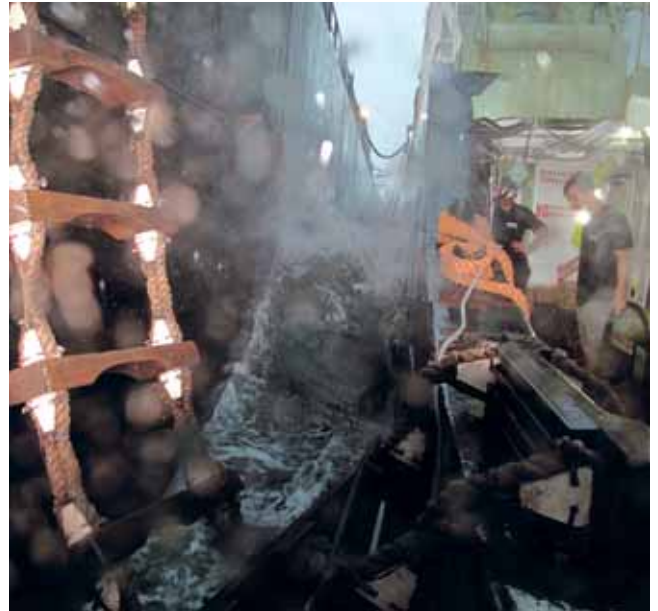
*Stormy weather conditions did not stop stern tube seal repair in Manila.*

A typhoon was crossing over the Philippines at the time the team arrived. The storm grew to a climax just after preparations had been made for the repair. Unfortunately this delayed the underwater operation by a day, beginning when the weather had improved slightly and full safety could be guaranteed for the divers.

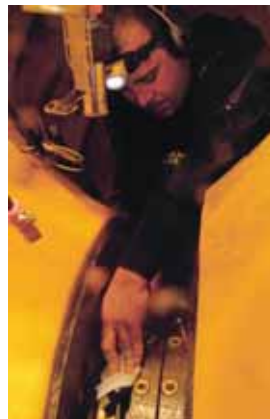
*Dry underwater stern tube seal repair inside flexible mobdock.*

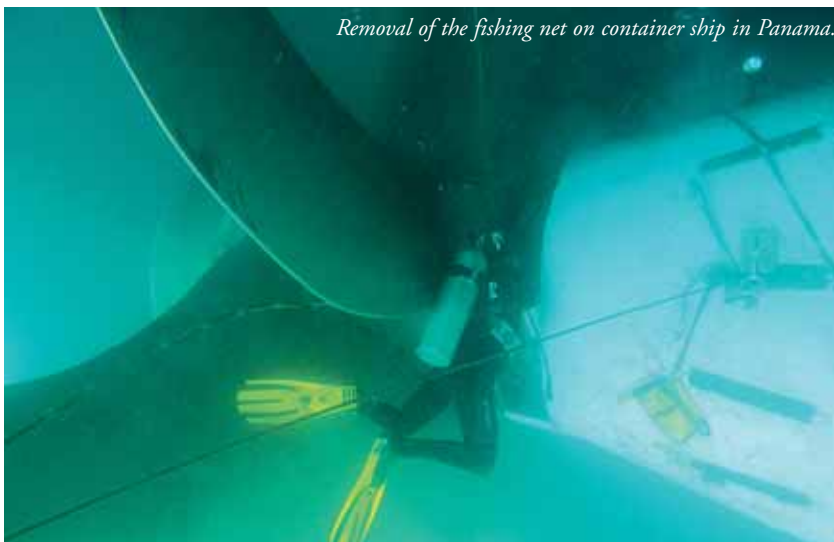
When a 295-metre container ship developed an oil leak from its stern tube seal assembly, caused by an entangled fishing net, Hydrex mobilized a diver/technician team to Panama where underwater repairs were carried out using the Hydrex unique flexible mobdock technique.

*Removal of the fishing net on container ship in Panama.*

Working closely together with a local support base, three seals were replaced in one smooth operation while the vessel was anchored at the entrance to the Panama Canal. Corrosion on the running area of the seals prevented the new stern tube seals from completely closing off the inside of the ship, so the decision was made to remove the spacer ring. This adjustment brought the seals beyond the corroded area.
